LBSCR *Terrier* 72 'Fenchurch' overhaul

Update - February 2022

Paul Russell, Bluebell Locomotive Director, introduces the work currently in progress:

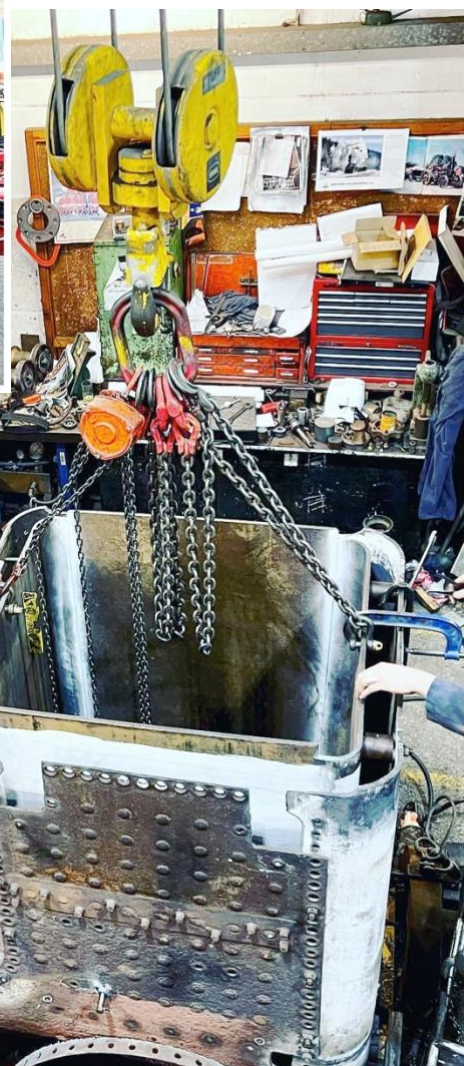
The new steel inner firebox made by Israel Newton (as per other *Terriers* which have had new fireboxes and boilers) is seen being test fitted to the boiler at Sheffield Park. The original outer wrapper has been bolted back in place to facilitate this.

Right: Simon Blaker and Henry Mowforth check the alignment of the new inner firebox.

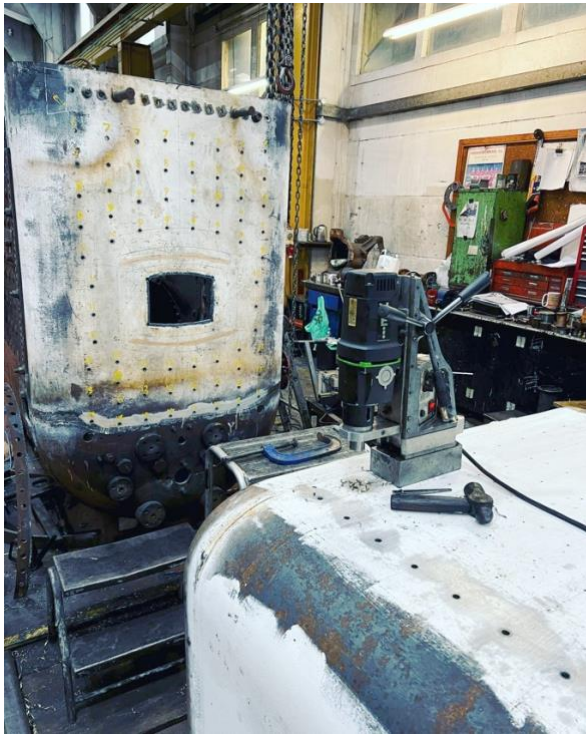
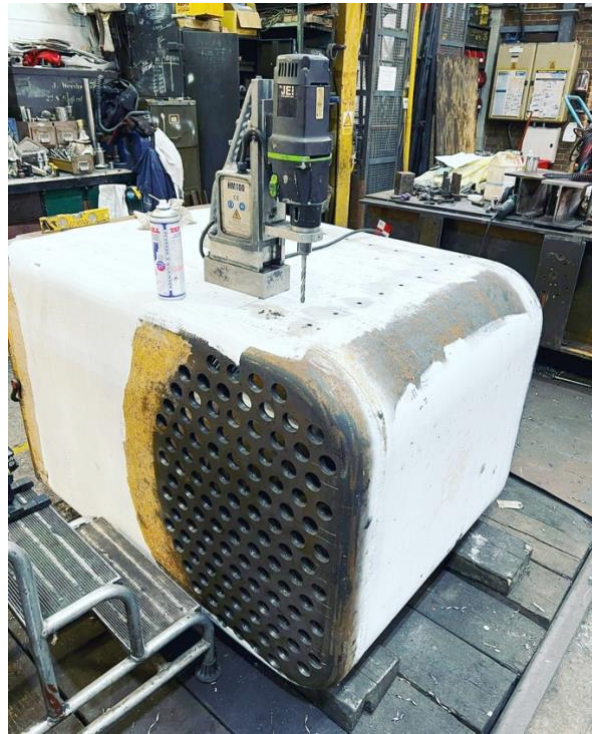
The new lower firebox outer backplate has already been drilled. Here we see the inner firebox sides being pilot-drilled.

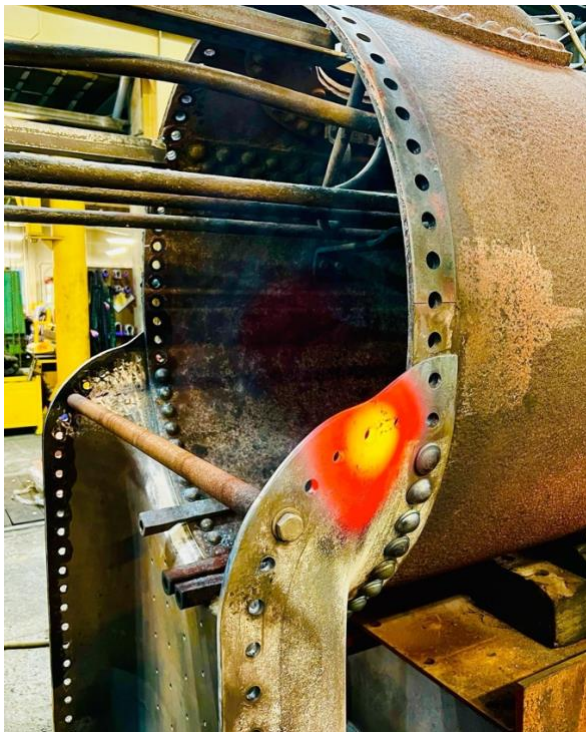
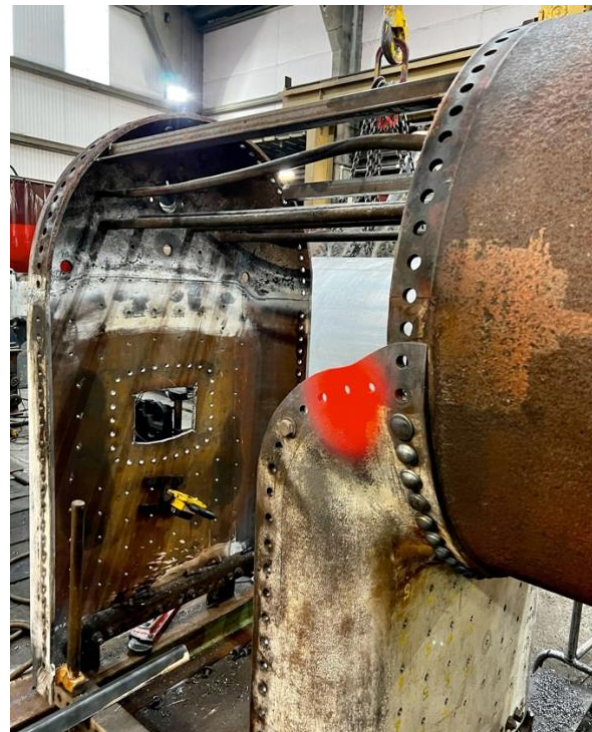
With the original foundation ring returned to Sheffield Park, work moves to final alignment of the new outer box. Here we see the tweaking of the throat plate to get a good fit to the new wrapper.

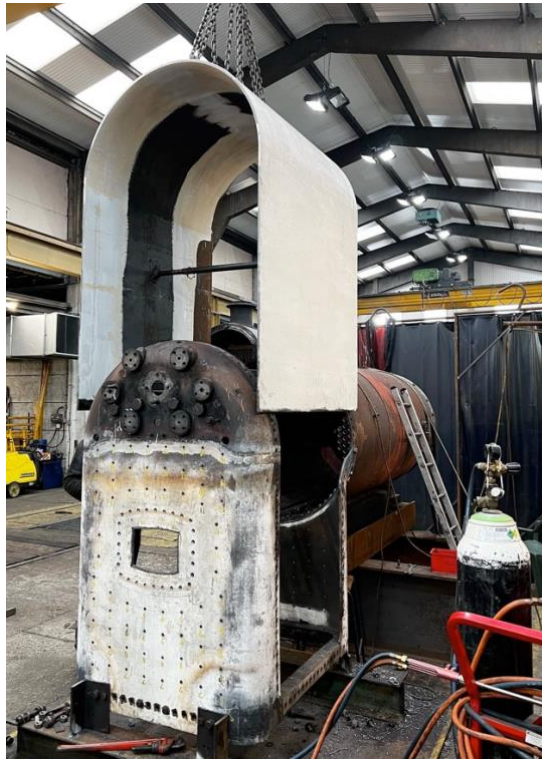
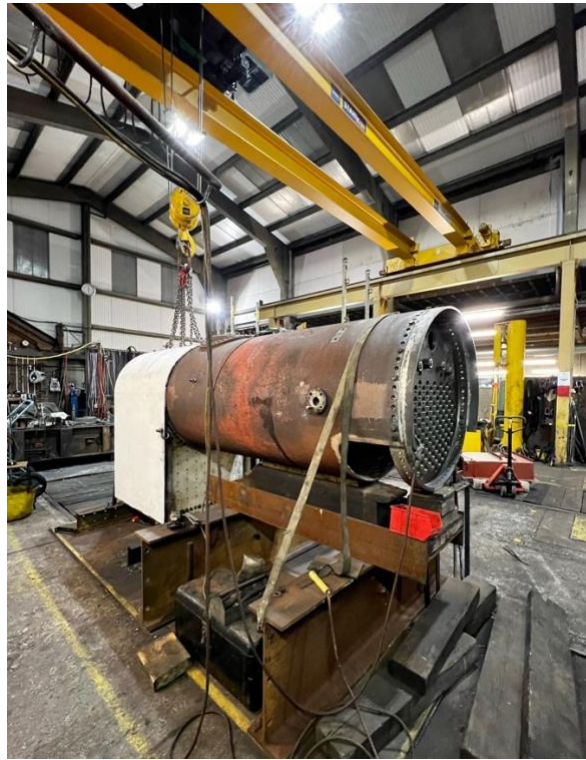
The new outer wrapper is lowered into place for a trial fit – which is perfect!

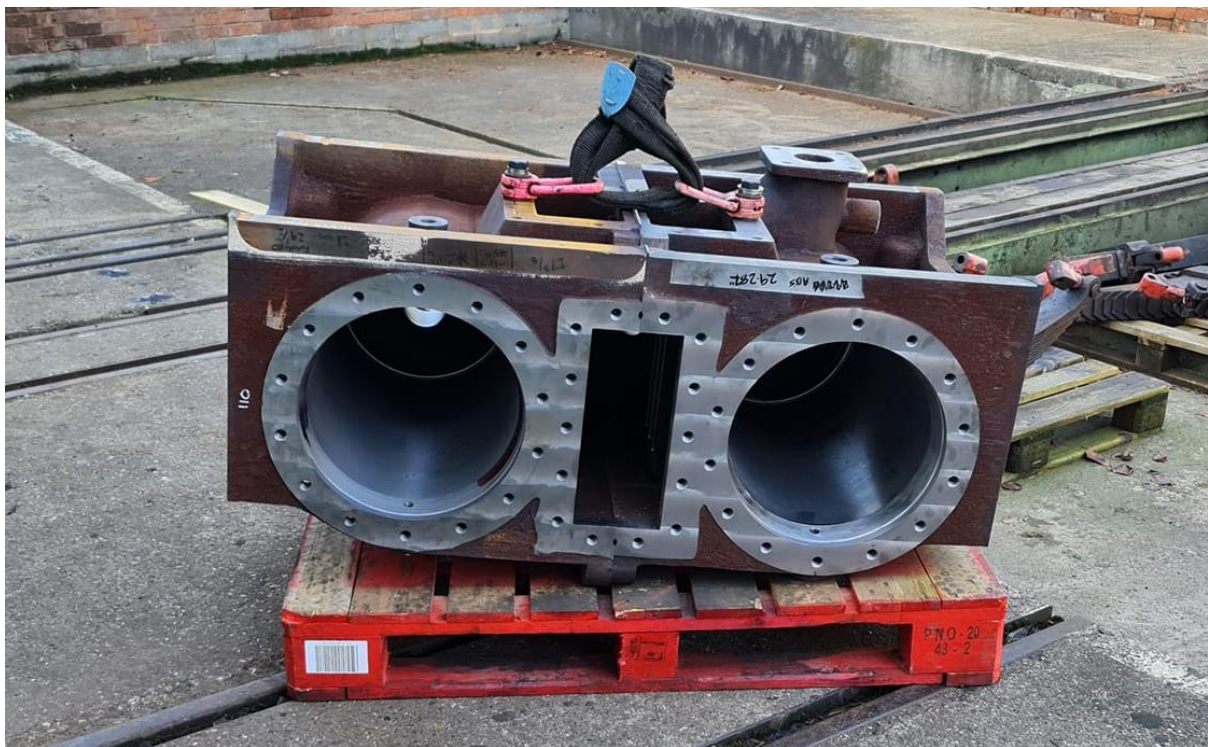
The new pair of cylinder castings are bolted together in readiness for trial fitting into the frames

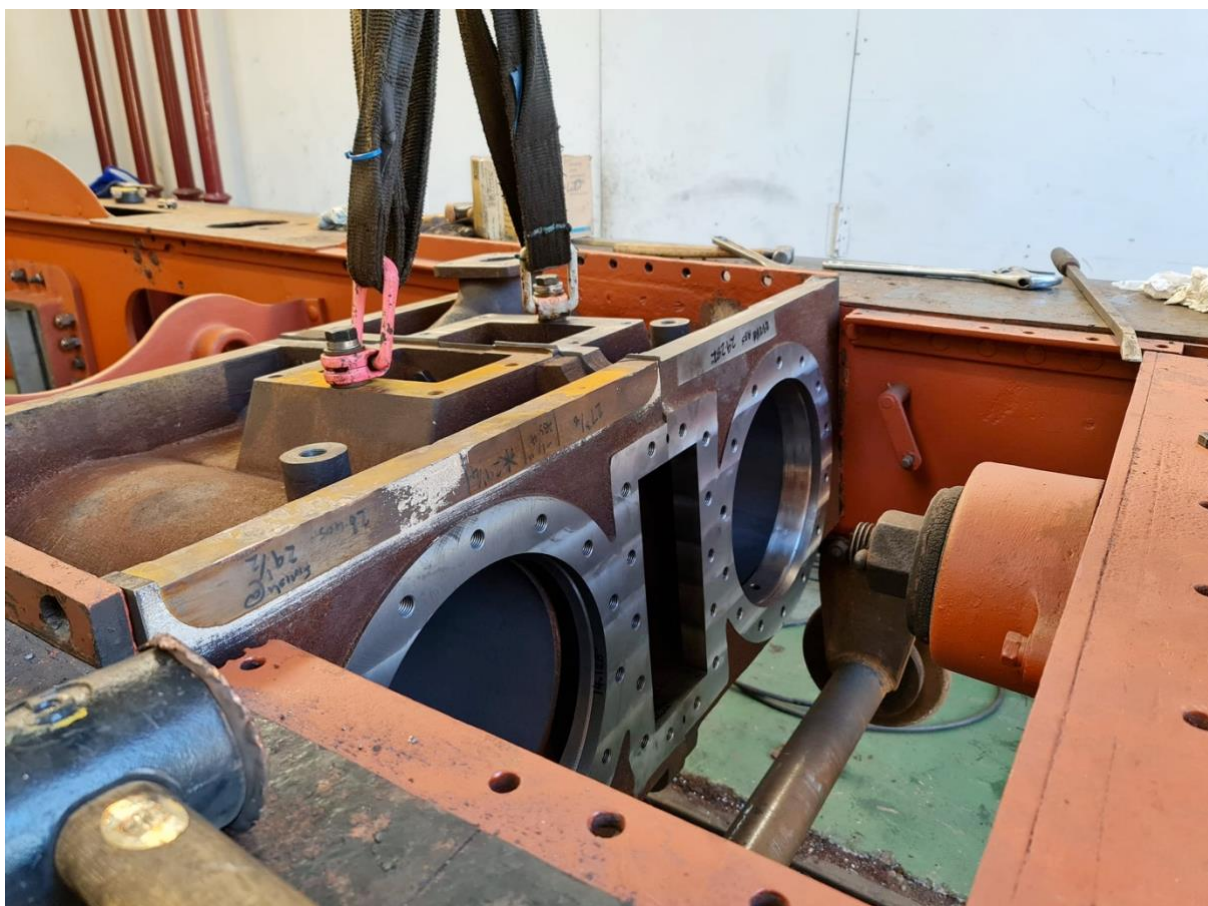
The cylinder block was lowered into position. This was achieved by measuring the old cylinder blocks and then machining the new cylinders to suit the existing holes in the frames.

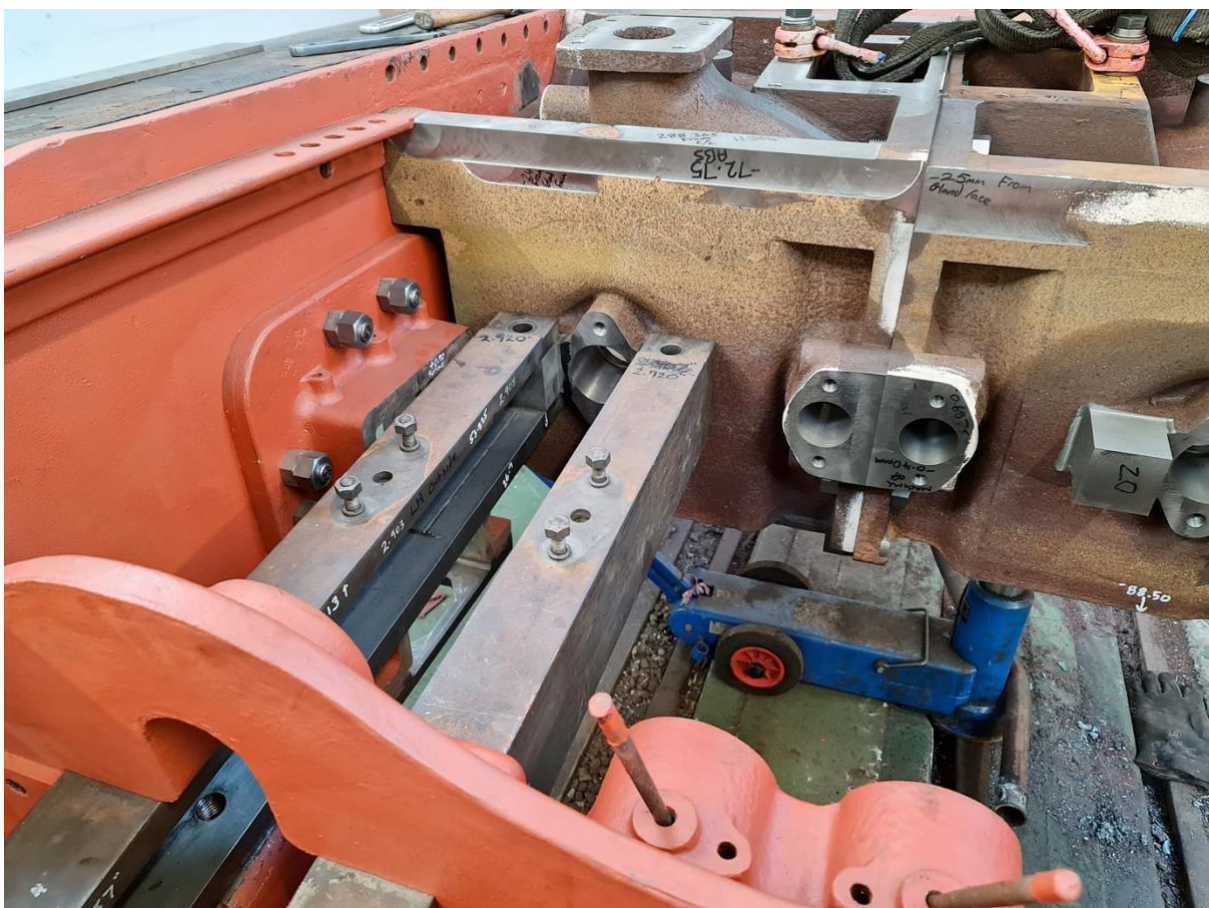
The guide bars trail fitted to check the alignment with the frames stretcher that supports the back of the guide bars.

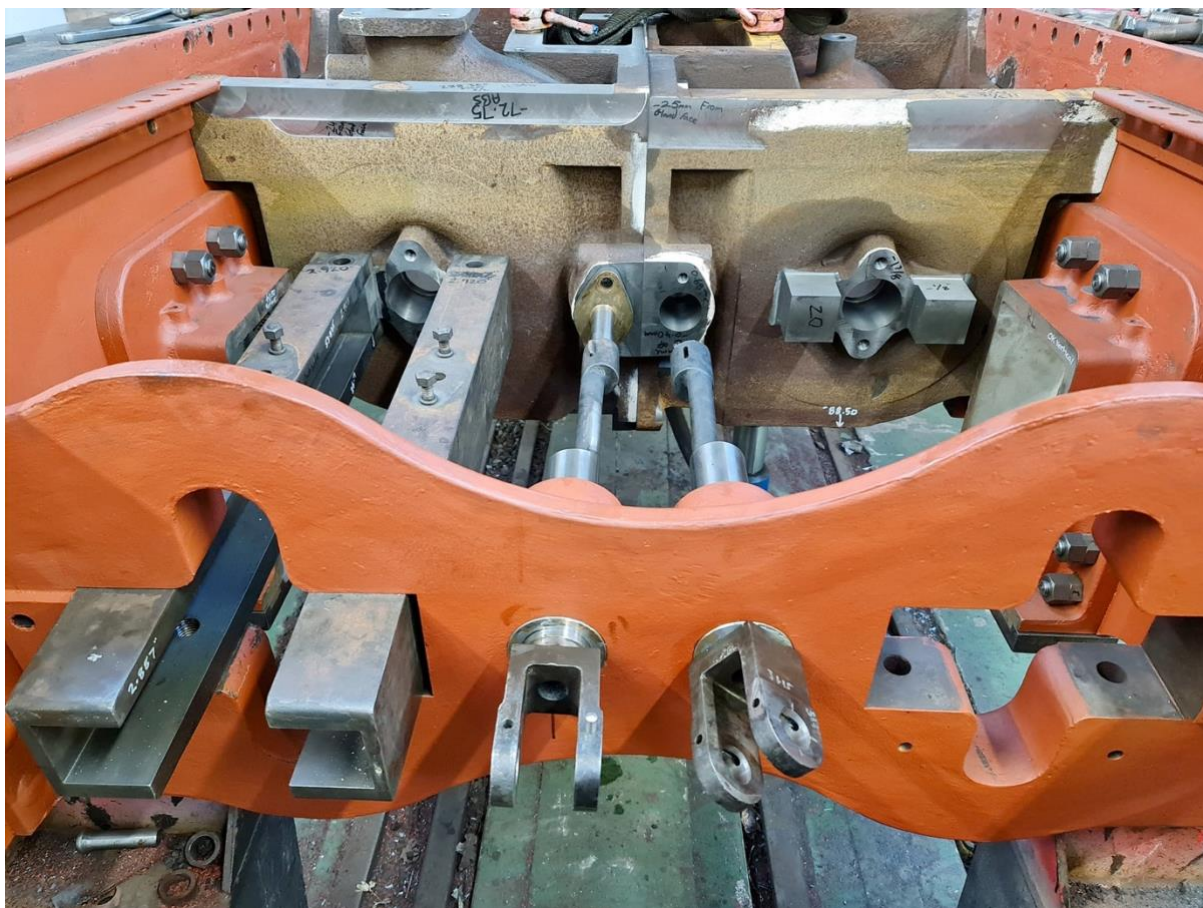
The valve rod assembly was trial fitted too. Only a small adjustment will be needed on the valve rods to ensure the correct fit and orientation.

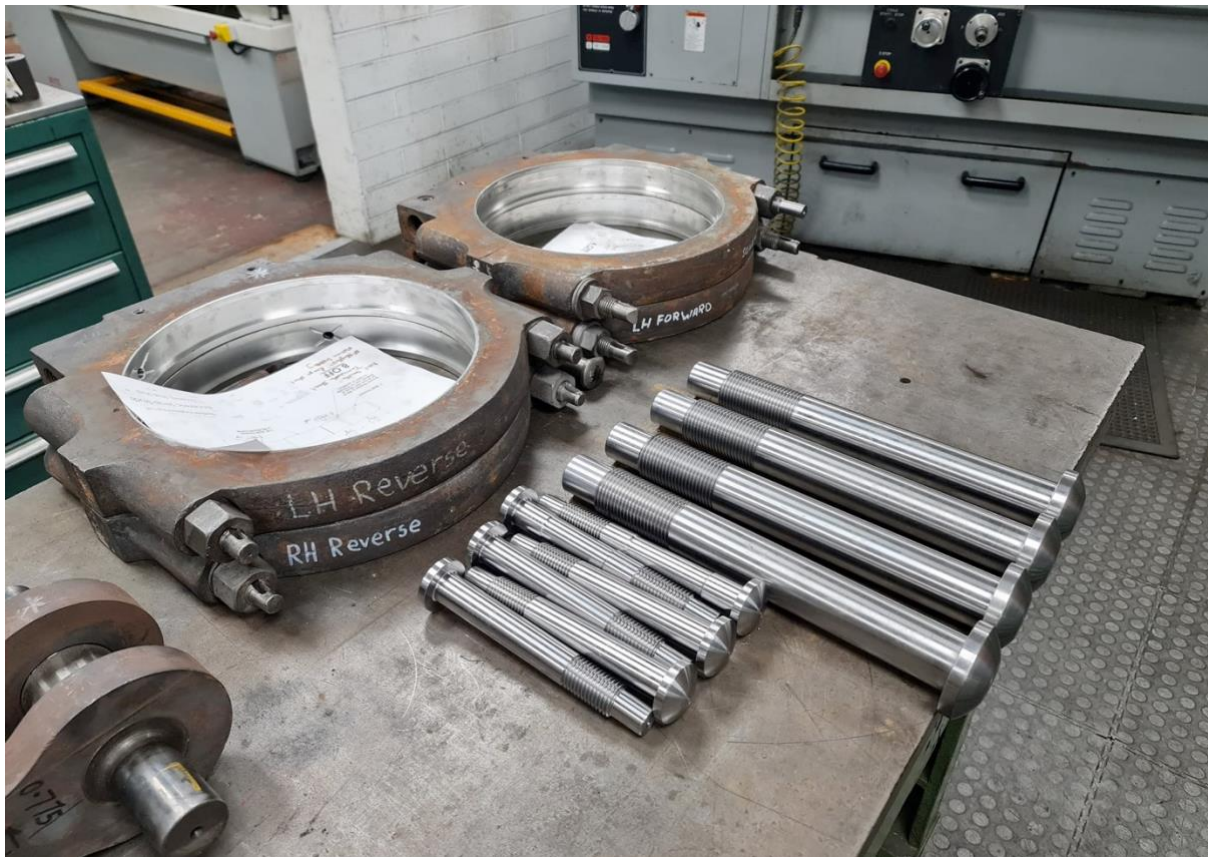
Work on the wheels and axles was covered in the last report. Ultrasonic and MPI tests highlighted cracks in the big end bolts and new items are being fabricated to replace these. An order has also been placed for the complete painting of the frames as this is more easily accomplished before the locomotive is re-assembled. It is anticipated that the frames will return at the end of March.

The eccentric straps have been white metallized and finish machined. The eccentric rod studs have been removed and new ones are to be made and fitted. This picture shows the replacement big end bolts, little end bolts and guide bar bolts. The old bolts were found to have cracking around the bolt heads under MPI inspection.

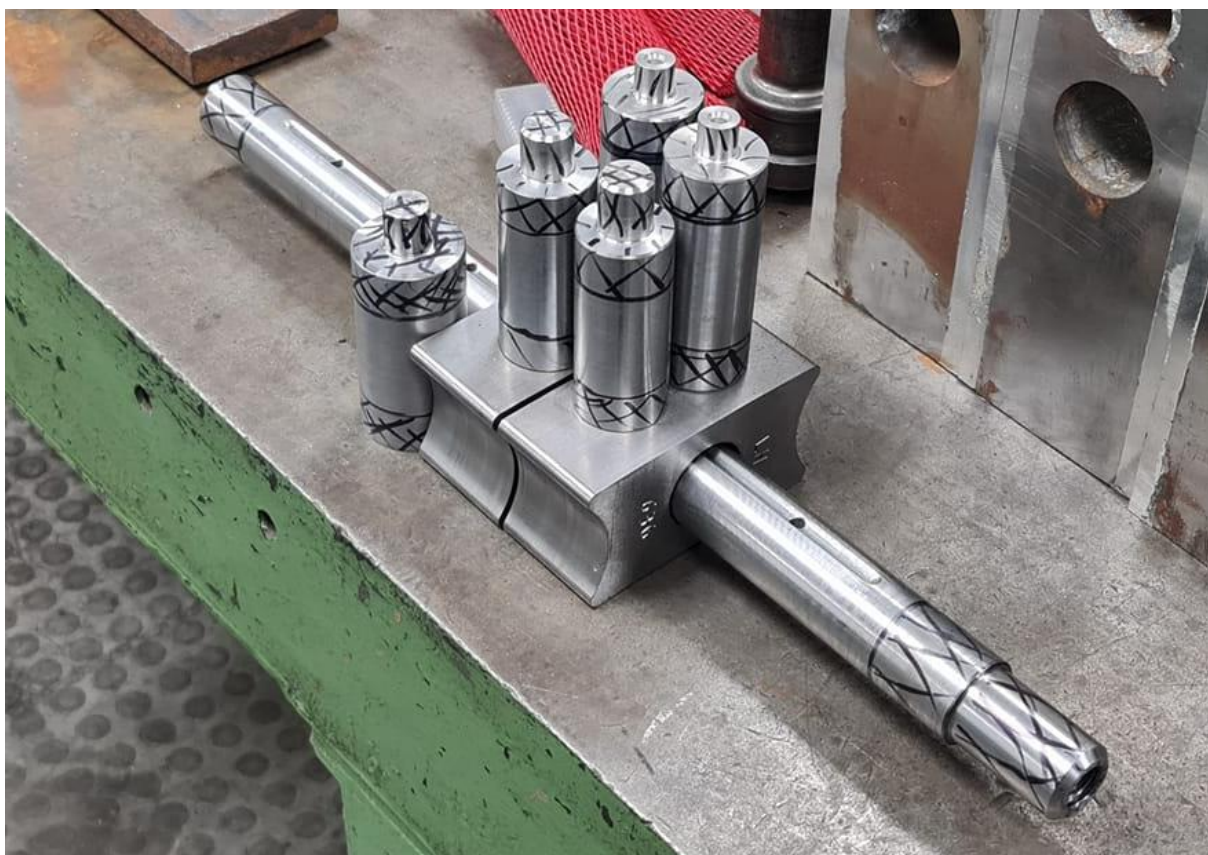
The new motion pins and die blocks have been made and are ready to go for hardening and then finish grinding.

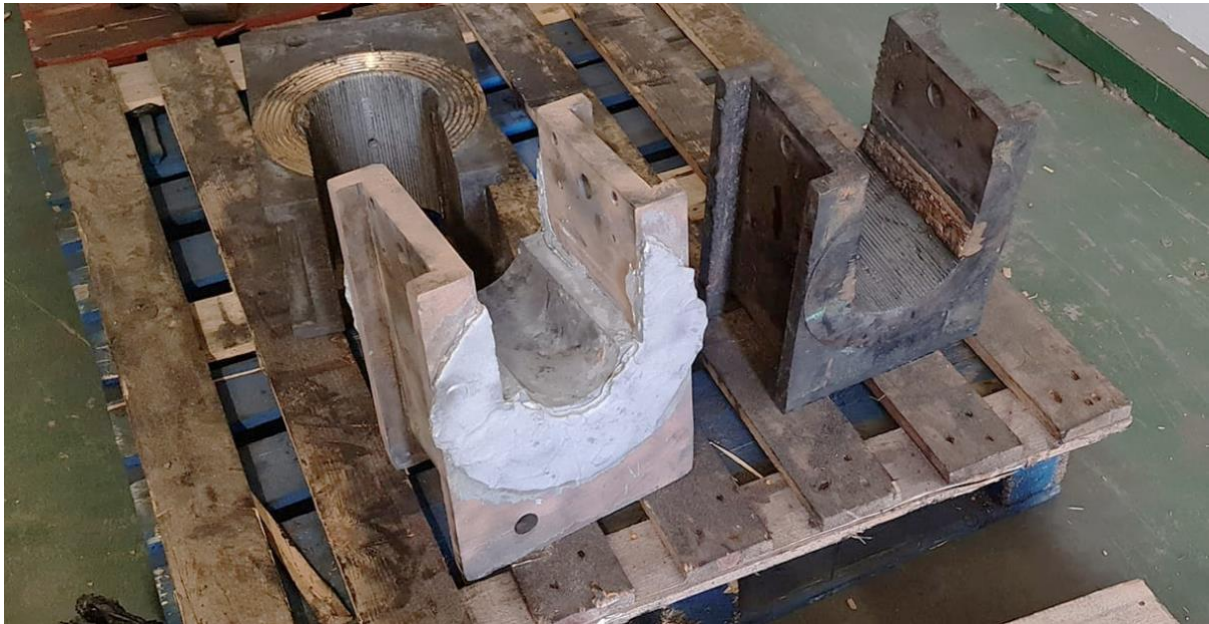
The axleboxes are in the process of being white metallised.

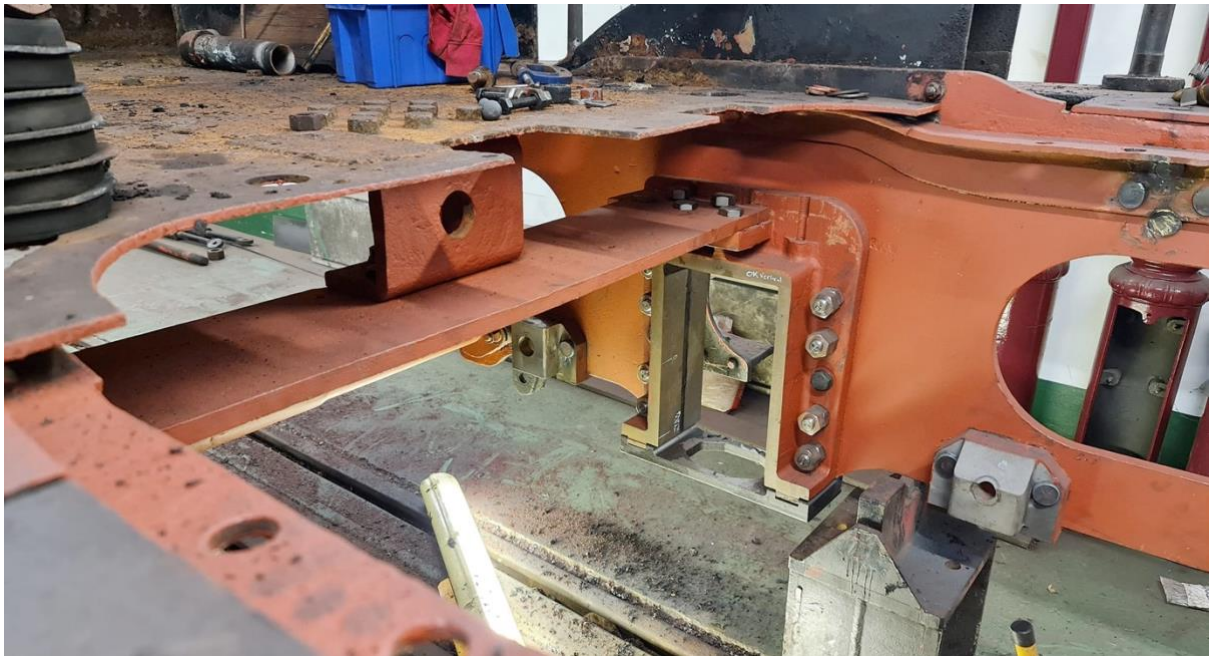
The rear horn guide stretcher has been removed, repaired and refitted.

The horn guides themselves have had the threads repaired in the top mounting brackets and new bolts made to secure the stretcher plate in position. This plate mounts the rear coupling, so it's essential for this to be firmly fixed to the footplate and the rear horn guide castings.

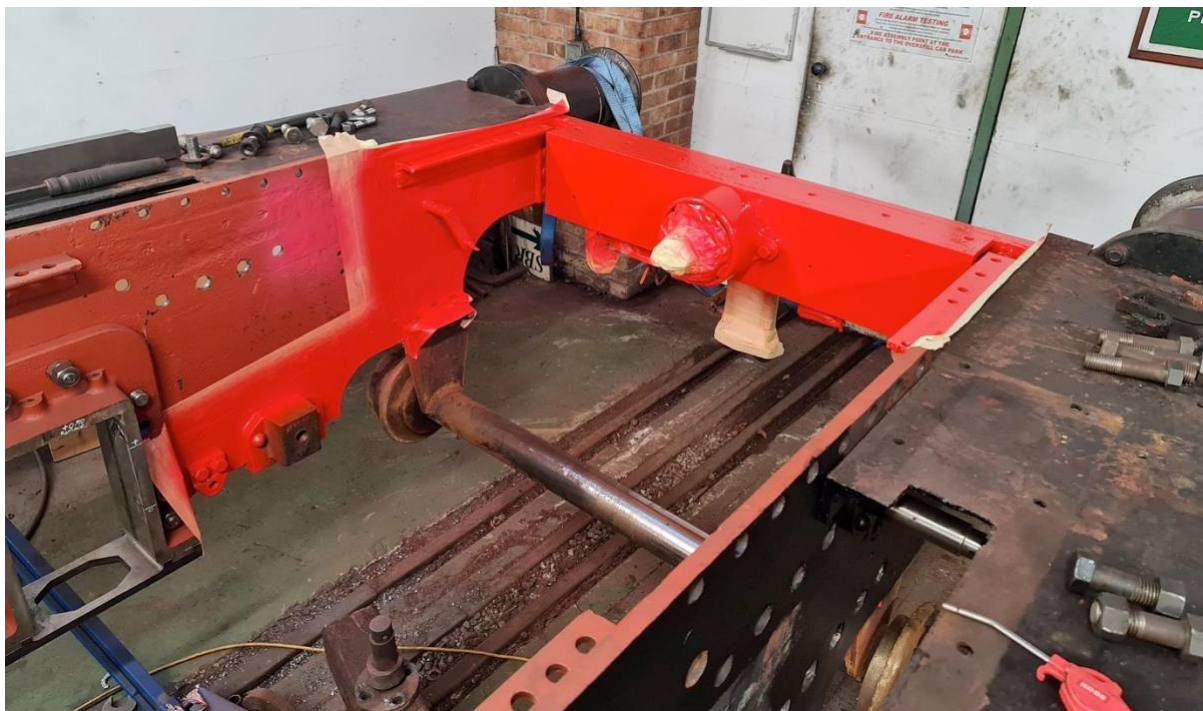
The front of the frames are being painted now, since when the cylinders are fitted, even the smallest of people wouldn't have a lot of room to work.

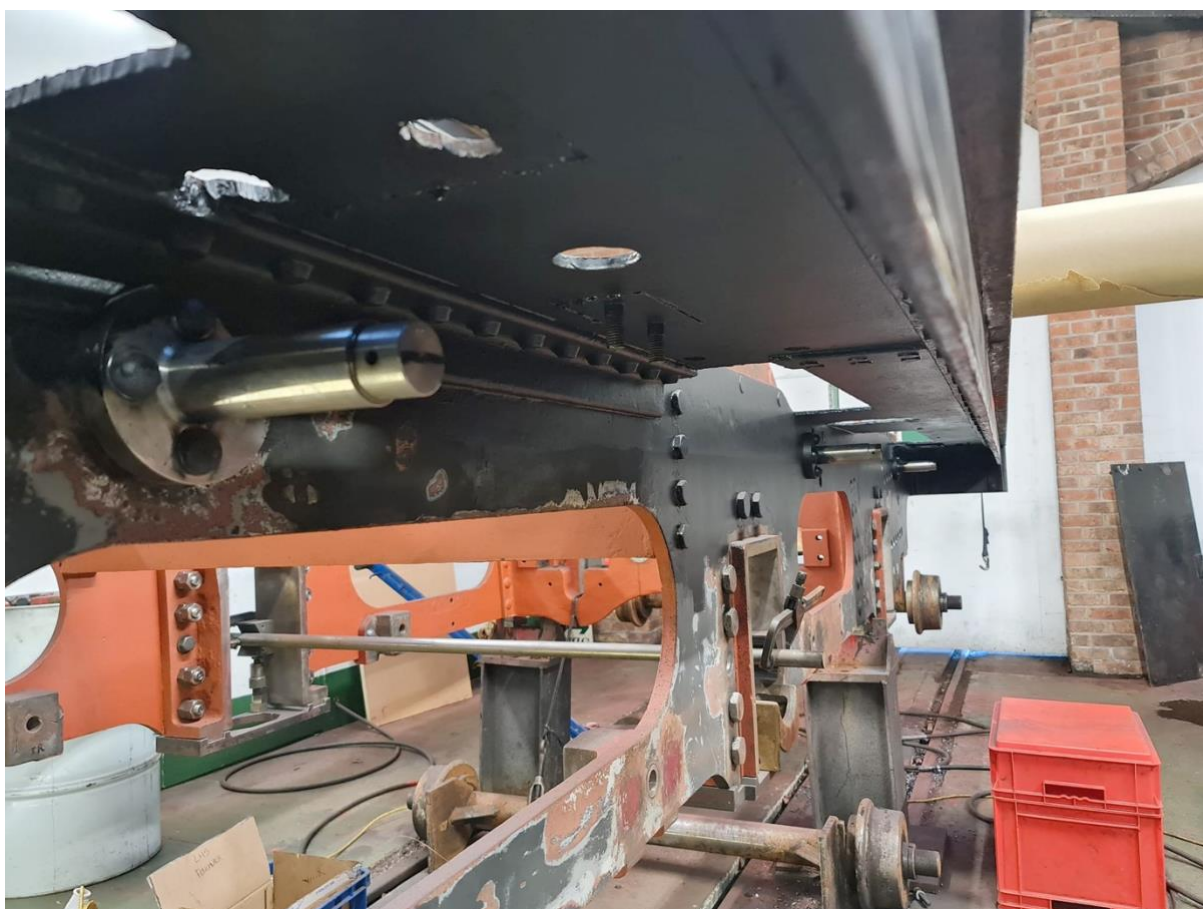
The new brake hanger housings have been made and riveted onto the frames.
