LBSCR *Terrier* 72 'Fenchurch' overhaul

Update - February 2022

Paul Russell, Bluebell Locomotive Director, introduces the work currently in progress:

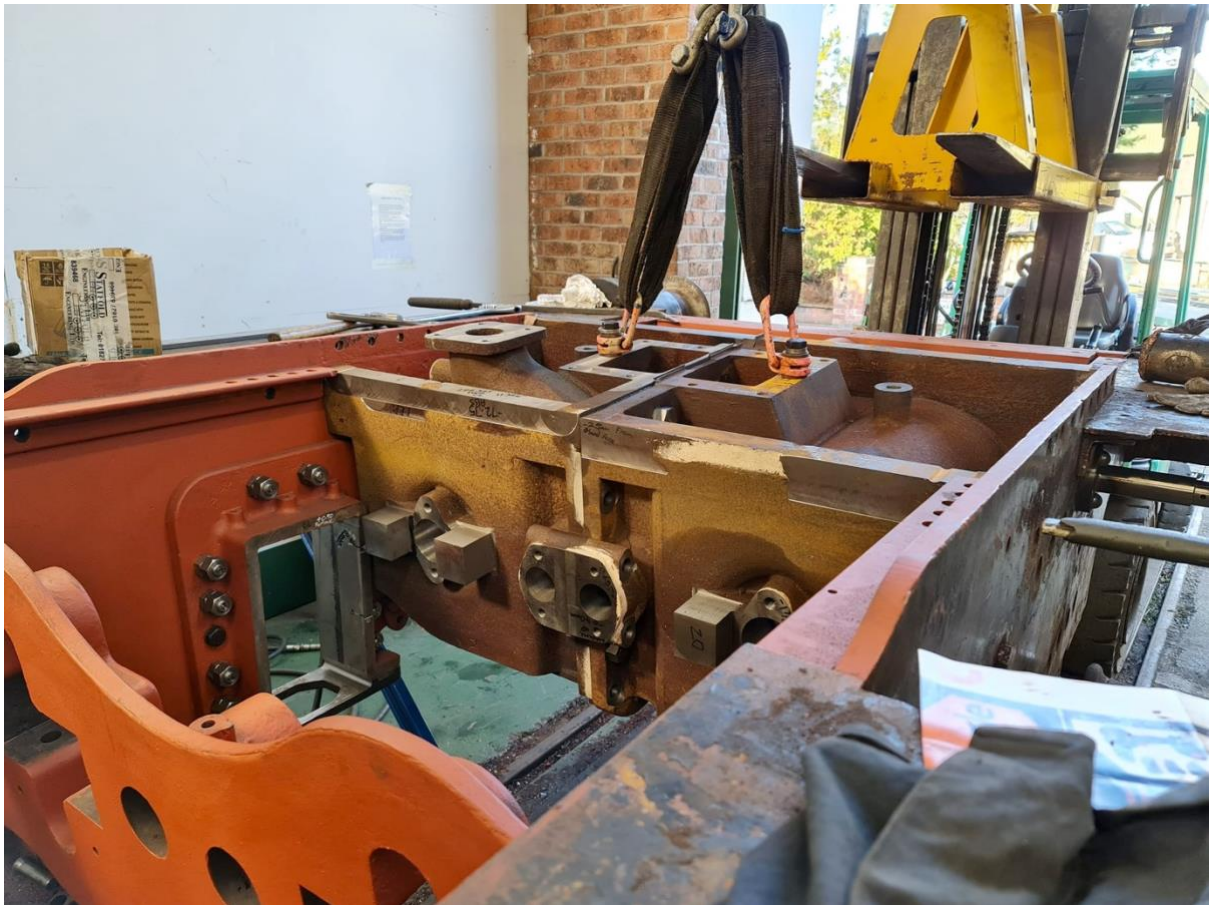
A view from the rear.

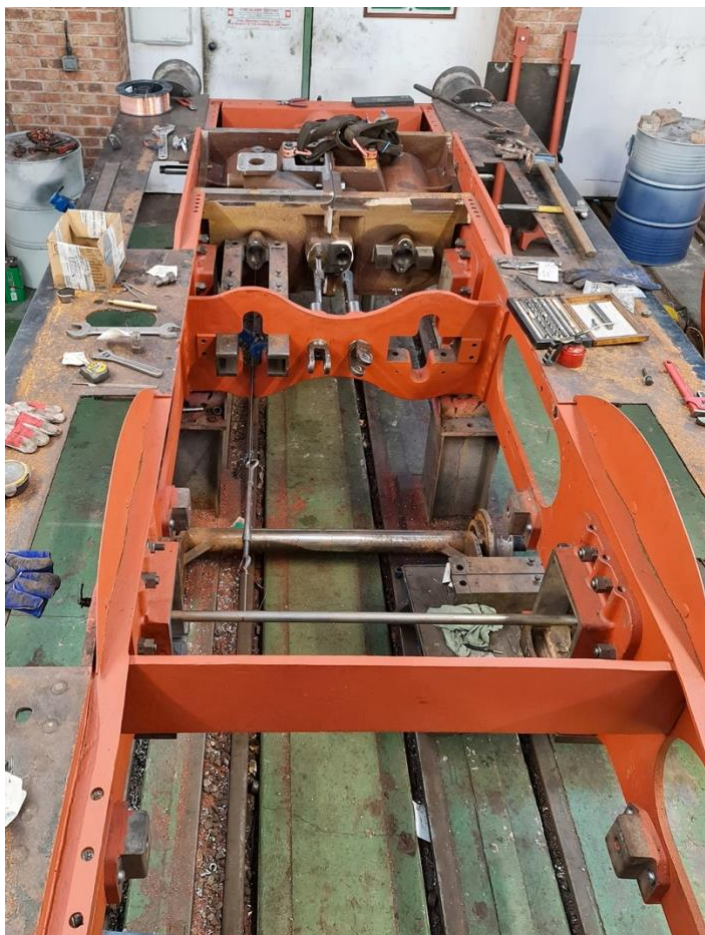
A view from the footplate.

A wire was used to check the positioning of the cylinders and guide bars. Once we were happy, the holes for locating the guide bars on the cylinder casting were reamed out with the mag drill and new fitted bolts made.
