Rolling Stock - No.5768

Dave Clarke

2018 has been a very successful year in the restoration of No.5768.

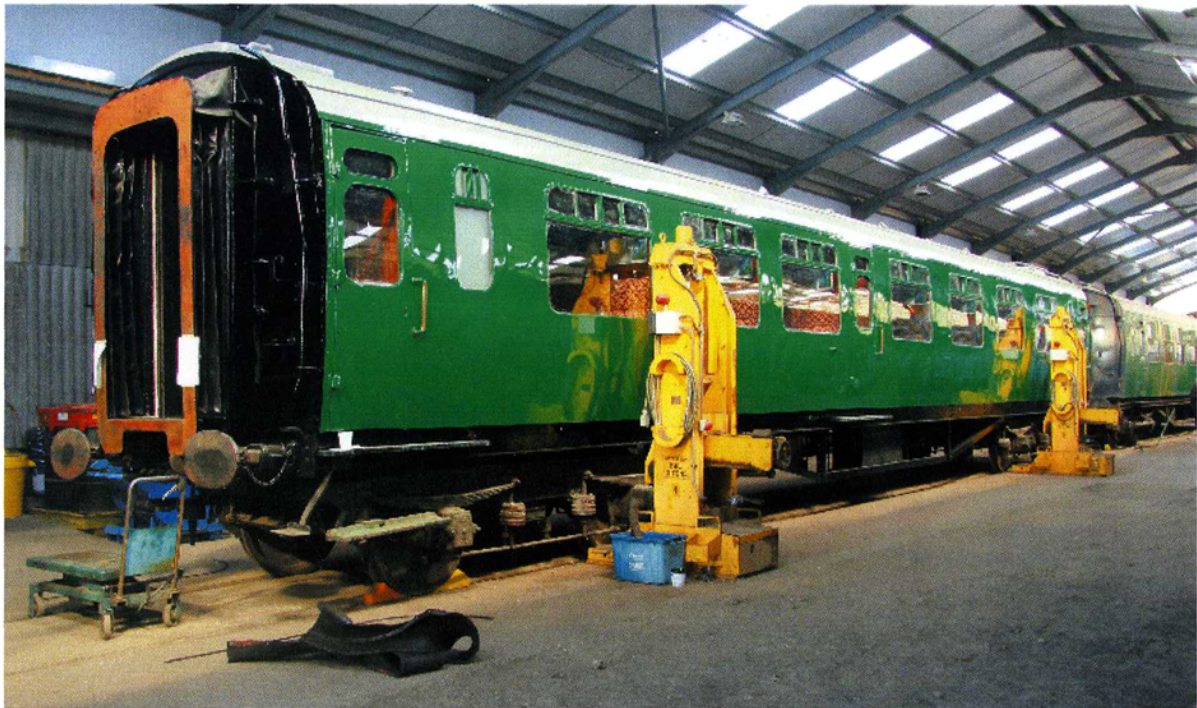
Resplendent from its time in the paintshop, No.5768 waits in the maintenance road for its new bogies to be overhauled and its underside to be set up. (Dave Clarke)

In November, No. 5768 was moved into the maintenance road for completion of the underside and the setting up of its systems and door locks. This includes connecting up the steam heat and vacuum pipework and the electrical wiring. The last major items to be completed are the bogies. A spare pair was identified early in the restoration for overhaul and swapping under the coach when it came to the setting-up phase prior to release into traffic. They were dismantled several years ago and have finally risen to the head of the queue for rebuilding.

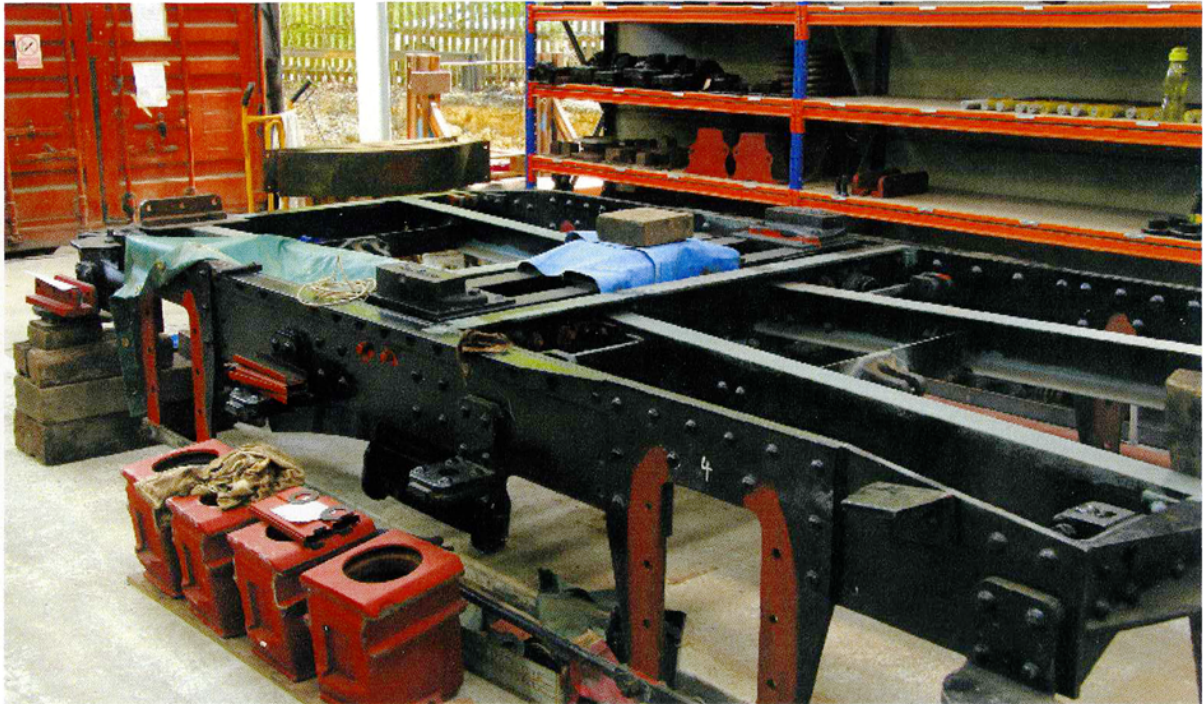
The partially rebuilt northern bogie awaits the fitted bolts required to attach the hornguides to the red painted sections of the bogies. Their role is to hold the axleboxes in the foreground. (Dave Clarke)

The individual components were assessed and the majority overhauled and painted. Amongst the remainder, the horn guides were condemned and new ones ordered. There are two on each corner of the bogie and are attached to the frames with fitted bolts. Their main purpose is to provide a contact face to hold the axleboxes and allow them to move up and down, against the action of the springs, as the coach travels along the track.

Reassembly of the bogies is in full swing, however the clearances between the axlebox and the horn guide has been found to be a little too tight for comfort and the latter may have to be machined to increase the gap a little. The bearing surfaces of the axles, and axleboxes themselves, have also to be 'blued' in before the bogies can be re-wheeled. They will then be swapped for No. 5768's originals which will in turn be put to one side for overhaul. One of the final jobs will be the installation and setting up of the brake rigging which can only be done once the coach is on its new bogies.

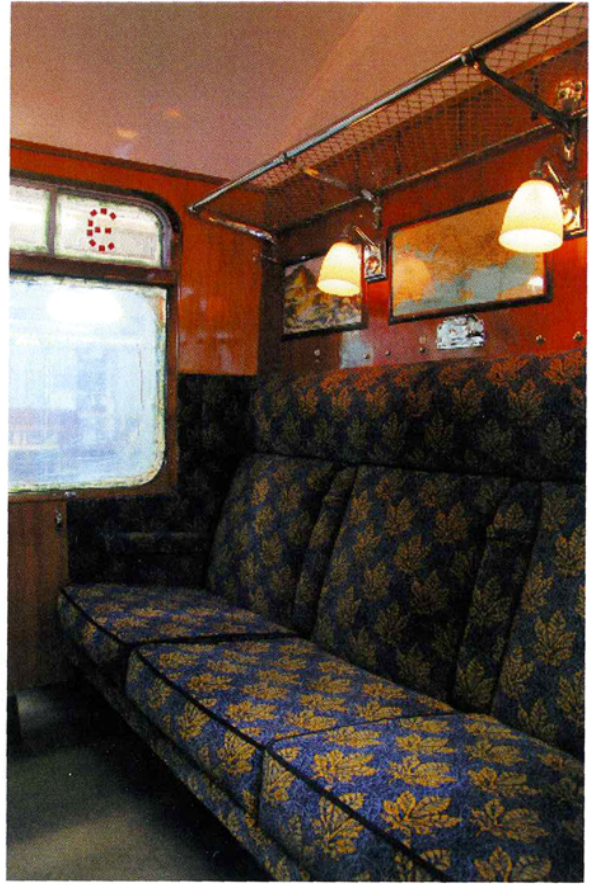
**The newly trimmed first class seats and cushions have been installed in compartment C.
(Dave Clarke)**

The last four first class seat backs and all 24 seat cushions have been received from the trimmer and installed in compartments A & B, which has allowed the last of the quarter lights to be installed in the corridor partition. New ply panels have been acquired, cut to size, varnished and fitted to the west side of the corridor and the hand or guard rails to be fitted across the side lights. The newly overhauled sliding compartment doors have been hung and the chrome table rack mounted against the lavatory partition at the northern end of the corridor.
